Manhole Inspection Summary

Manhole # S33E__050MH

Insp Date: **10/27/08 10:39 AM**

Location Address: **12 n calvert st**

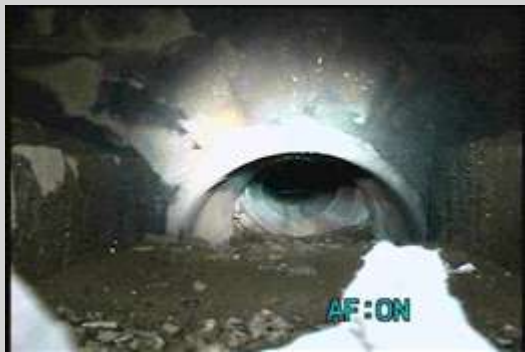
12 O'Clock Outflow

10 in. Circular Gravity Sewer
Pipe Out @ 12 O'Clock

Infiltration: **None** Pipe Seal Cond: **Unknown**
